Japanese Knotweed Case Study

Job Type: Commercial
Site Size: 2500 m²
Location: East Midlands
Techniques: Excavation
Membrane barrier

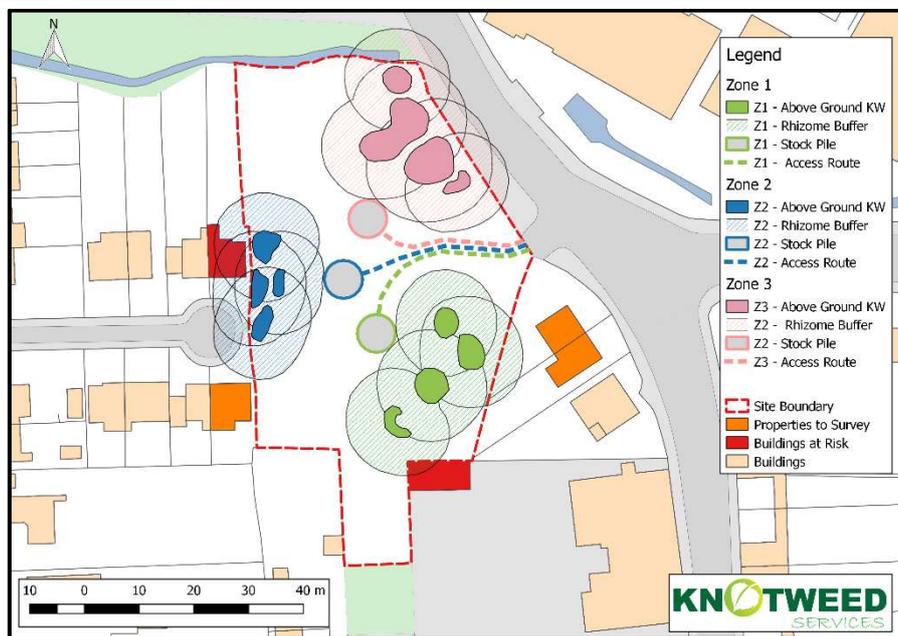
Figure 1: Site map showing knotweed zones, rhizome extent, proposed tipper and stockpile routes. Authors Work.

The mapping stage of our plans is crucial to preventing spreading of the Knotweed. We created detailed maps with clear working routes and areas for stockpiling contaminated and non-contaminated soil (figure 2).

Vertical barriers - For some areas (see yellow houses on map) Knotweed was found near the site boundary. Because the client did not have permission to treat this area

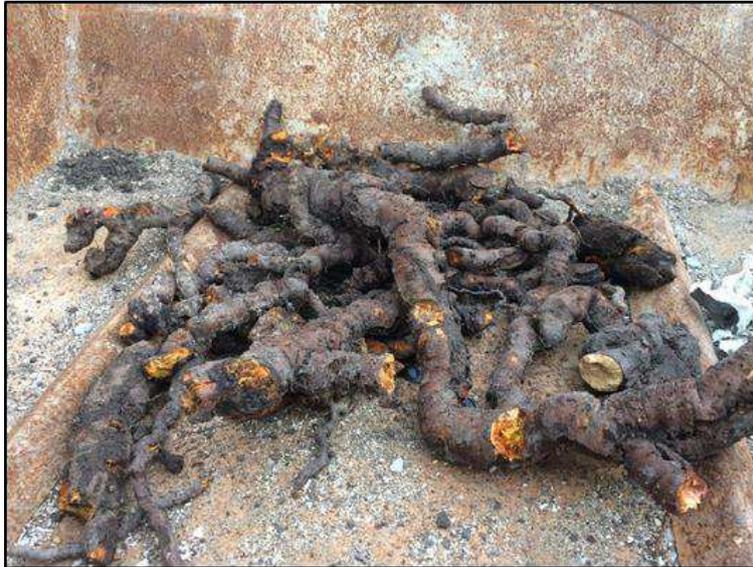
Figure 2: Some of the excavated Rhizome.

We then proceeded to excavate the infested soil (figure 2). The soil was transferred to the stockpile and then to removal trucks with retractable covers to prevent spreading to clear areas. Before leaving site all trucks tyres were treated with herbicide to create a chemical barrier. The waste was carted to a specialist contaminate waste landfill site. All working areas and plant used for the exaction were also treated after completion. This method provided a quick solution to Knotweed eradication which is why it was the most suitable for the client.

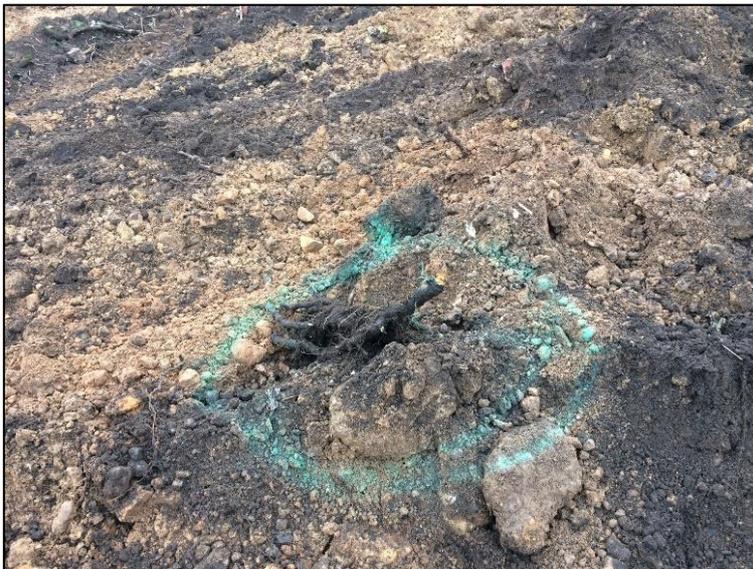
Figure 3: Knotweed rhizome fragment identified.

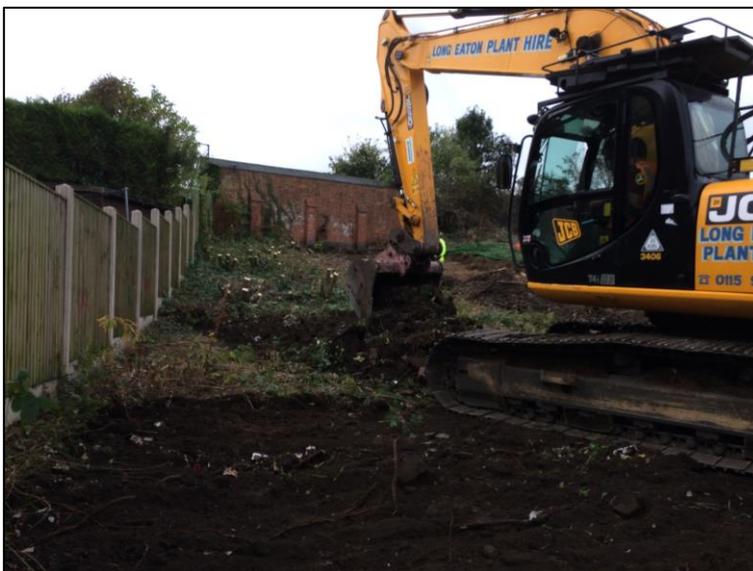
Figure 4: Supervised excavation in progress.

From this we were able to deduce that a supervised excavation and off-site removal was the most appropriate treatment option. All site operations (e.g. tree felling and excavation) occurring in the fenced zones were supervised by one of our trained operatives.
